Inspection Report

Property Address:
500 Sea Breeze Dr
Dallas TX 75104

PROPERTY INSPECTION REPORT

By: Kevan Brent Giles TREC # 7297 / Spec-Pro Inspection Services, LLC 6/18/2010

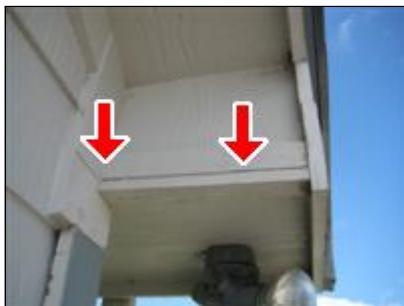
E. Picture 1 OPENINGS IN SOFFIT

NOTE: Open penetrations may allow moisture, insects, and/or pests to enter if not corrected and maintained as needed. Therefore, it is recommended sealing these areas as necessary to prevent further deterioration.

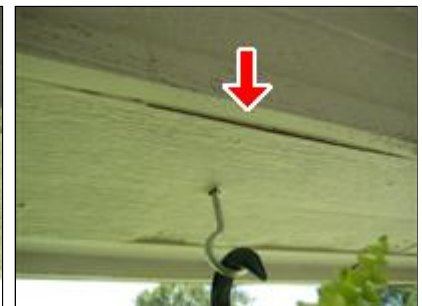
E. Picture 3 SEAM OPENINGS

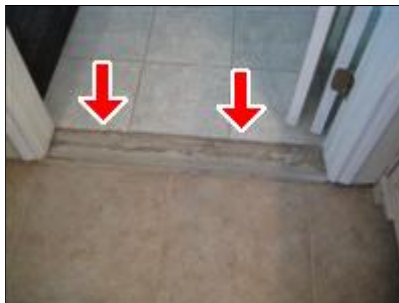
G. Picture 1

Doorway threshold is unfinished and baseboard materials missing at the master bathroom. This can be a tripping hazard if not corrected. Recommend installing the proper threshold, transitions, and baseboard materials as necessary for normal function.(Picture 1)

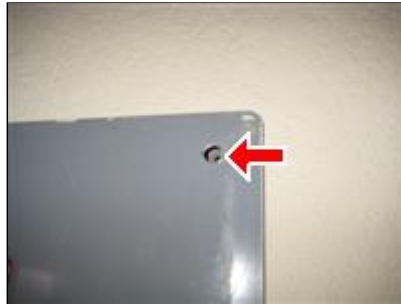
A. Picture 1

(3) One service panel screw missing in panel-box at room add-on location. Recommend installing a non-pointed screw approved for electrical use.(Picture 1)

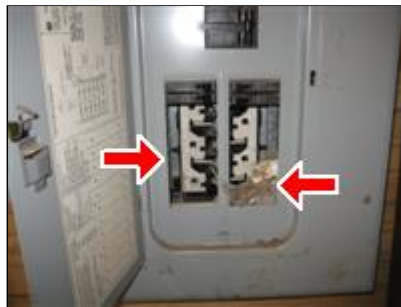
(4) Combustible materials observed inside sub-panel box at horse stable should be removed. Plug covers or breakers missing over charged circuitry components can be hazardous if not corrected. Recommend service as necessary for safety.(Picture 2)

A. Picture 2 SUB-PANEL IN STABLES

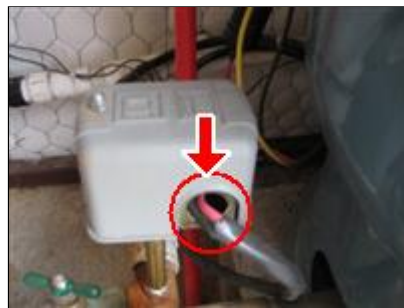
(3) Wire-stops (bushing protectors) missing around wire conductors, where sharp metal edges can cut into sheathing. Plug covers are also needed where openings into panel boxes are present. Electrical issues can be hazardous until corrected and should be performed by a certified electrical contractor.(Picture 6)(Picture 7)(Picture 8)(Picture 9)(Picture 10)(Picture 11)(Picture 12)(Picture 13)

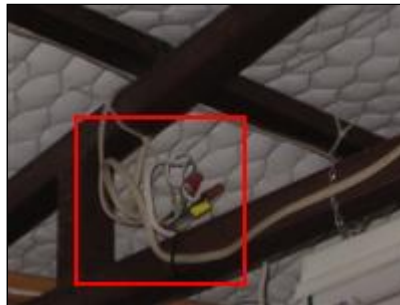
(5) Open wire splice connections observed at each fluorescent light fixture location inside metal garage. According to electrical standards, wire connections should terminate inside an approved junction-box as necessary for safety.(Picture 16)

B. Picture 16 Missing J-Boxes at Metal Garage Lighting

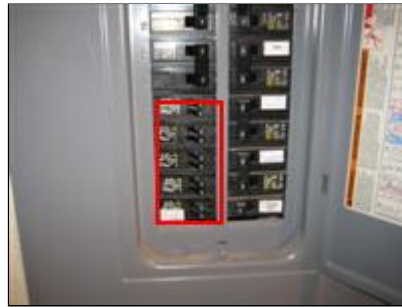
🏠 (9) The electrical system does not have AFCI (Arc-fault circuit interrupters) protection at required locations in bedrooms and living areas as necessary for safety. **This standard was not enforced and may not have been required when the home was constructed.** AFCI Protected outlets were effectively introduced January 1st, 2002, and was mandated by the NEC (National Electric Code) to protect 15 and 20 amp branch circuits servicing bedrooms in new construction. This is not a new home, so simply

B. Picture 22 Missing AFCI Breakers

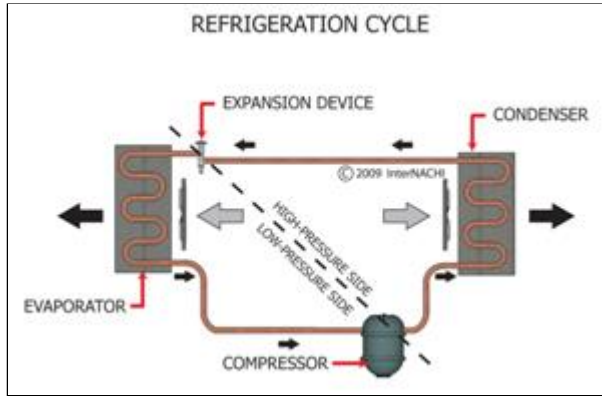
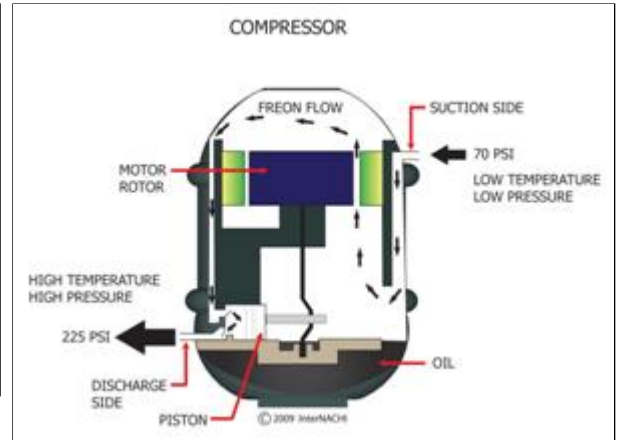
(1) The air conditioning equipment is a split system, in which the cabinet housing, the compressor, cooling fan, and condensing coils, were located physically apart from the evaporator coils. As is typical with split systems, the compressor/condenser cabinet was located at the home's exterior, so that the heat is collected or absorbed from inside the home and then released to the outside by conduction. The indoor evaporator coils are designed to collect heat from the interior, cool it down with refrigerant (Conduction), and then return the conditioned-cooler air back into the room by convection.(Picture 1)(Picture 2)

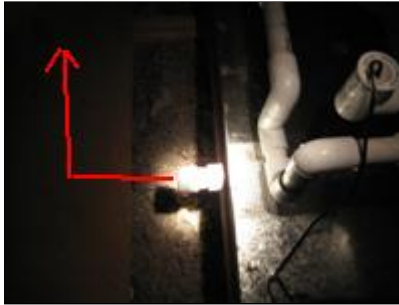
🏠 (4) 3/4 inch PVC drain line missing to drip pan supplying service to the room add-on location. Secondary drain source should be installed and plumbed to terminate at an outdoor soffit-panel location.(Picture 6)

B. Picture 6 DRIP PAN AT SMALL AC

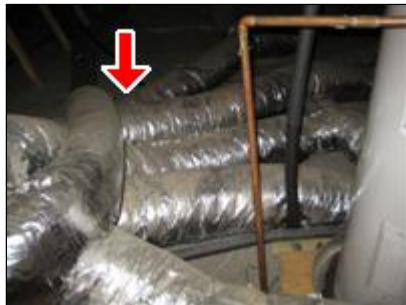
Flex ducting should be hung properly from rafters and not lay directly on ceiling joists. Noise vibration, eventual collapse and deterioration of the bottom sides of the ductwork can occur if not properly hung as suggested by today's standards and/or manufacturer's requirements.(Picture 1)(Picture 2)

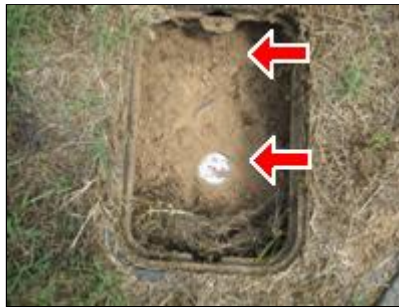
A. Picture 1

(1) Main water meter is buried under soil at street in front of property. Recommend removing soils as necessary for normal function.(Picture 1)

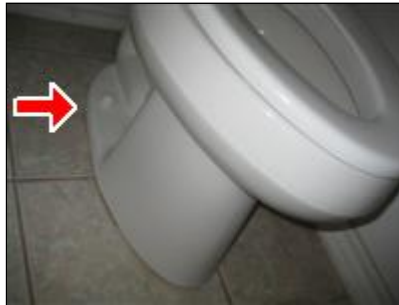
A. Picture 2

(2) The toilet is loose at floor at master bathroom location. Repairs may involve re-setting the toilet on a new wax seal. I recommend a qualified licensed plumber repair or correct as needed.(Picture 2)

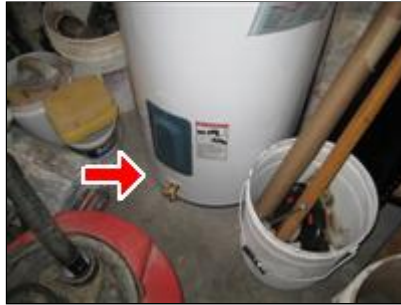
C. Picture 1

(1) Water heater is located directly on the floor of the metal garage where a vehicle can come into contact with unit. Standards require that all water heaters located inside garages should be installed no less than 18 inches off the floor or as necessary for safety. Due to deficiencies noted, it is recommended that further evaluation(s) and/or repairs be performed by a qualified person and/or certified plumbing contractor.(Picture 1)

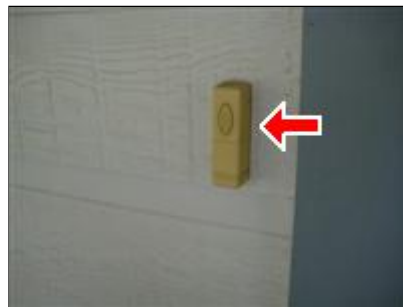
I. Picture 1

Door bell did not work when tested at front of home. Standards recommend that a hard-wired door bell type of system should be present, which are considered more reliable than battery operated units. (Picture 1)

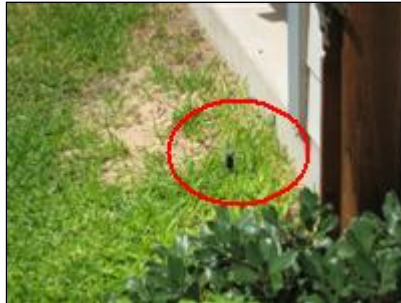
(1) Zones # 3 has a broken and/or damaged sprinkler head(s) at right side (Facing front) of structure. Recommend service before further usage.(Picture 1)

A. Picture 1 Zone# 3 damaged head

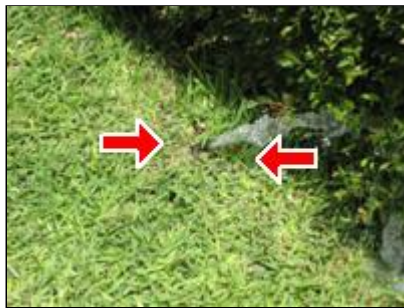
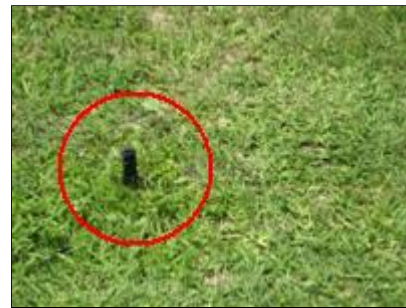
(2) Zones # 7 has 2 broken and/or damaged sprinkler heads at front of structure. Recommend service before further usage.(Picture 2)(Picture 3)

A. Picture 2 Zone# 7 damaged heads

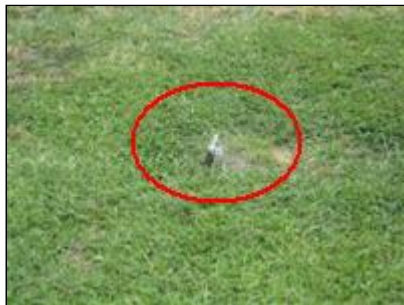
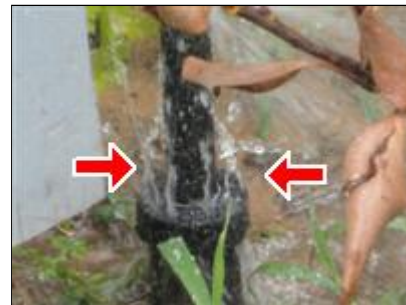
(3) Zones # 9 has 2 damaged sprinkler heads at rear of structure. Recommend service before further usage.(Picture 4)(Picture 5)

A. Picture 4 Zone# 9 damaged heads

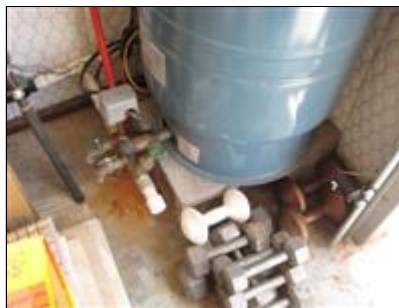
F. Picture 1

(1) Well pump, pressure tank, and related components appear to be properly installed to manufacturer's requirements and is performing the functional purpose intended at time of this inspection.(Picture 1)

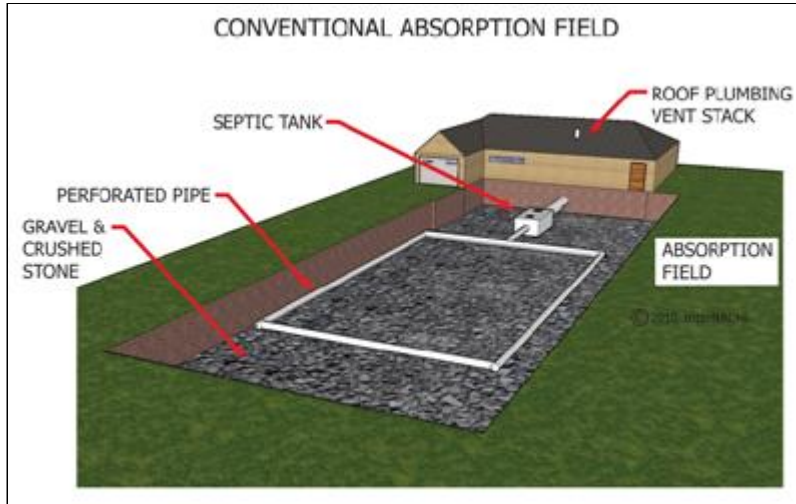
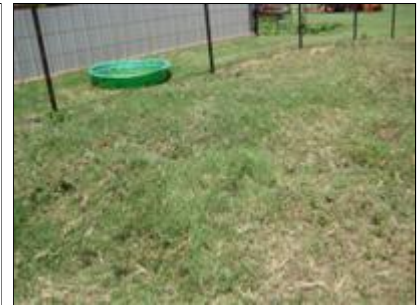
This inspection did not access the tank into the onsite septic system at rear of main structure. For a more detailed inspection, I recommend you contact a septic pumping company and have them clean it. At that time the system can be properly inspected for normal function. This may be especially important, if recorded documentation on the maintenance history of this system is not available.(Picture 1)(Picture 2)

G. Picture 2 COVERED BY SOIL
