# Inspection Report

**Property Address:**  
5006 Monticello Rd  
Dallas TX 75206

**Spec-Pro Inspection Services, LLC**

**By:** Kevan Brent Giles TREC # 7297 / Spec-Pro Inspection Services, LLC 6/9/2010  
\_\_\_\_\_  
(Name and License Number of Inspector) (Date)  
\_\_\_\_\_  
(Name, License Number and Signature of Sponsoring Inspector, if required)

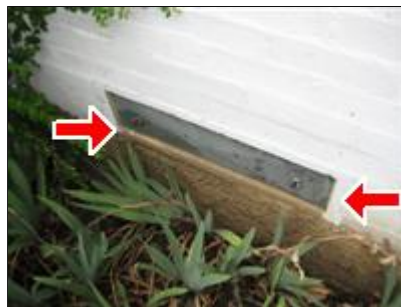
A. Picture 1

(1) Foundation vents are closed off at sides and front of home. Excessive moisture content and standing water under the structure is conducive if not properly ventilated. Not opening the vents when moisture is present could further harm your floor system or contribute to mold. I recommend opening the vents in the summer and closing some of them in the winter.(Picture 1)

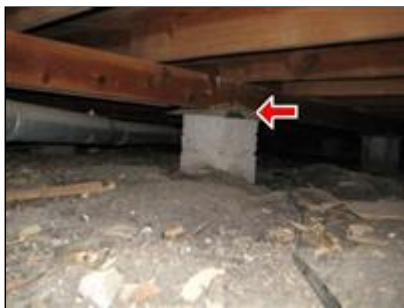
A. Picture 2

(2) Concrete pier(s) not aligned properly or are missing in areas under structure where sloping appears to have occurred. Areas of the structure may need more support and/or stability applied near front of the structure. Recommend further evaluation(s), service, or repair be performed by a qualified foundation expert.(Picture 2)(Picture 3)(Picture 4)

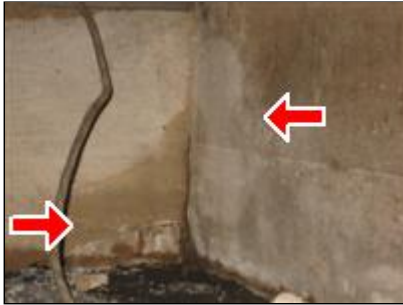
A. Picture 5

(3) White efflorescence (powder substance) on floor-joists and on inside foundation walls indicates moisture is, and/or was, in contact at various locations under structure. A moisture condition may still be present and may require additional ventilation. Efflorescence is found on many homes without water intrusion. But, should alert you to the possibilities of future steps that may be needed to correct this condition.(Picture 5)(Picture 6)(Picture 7)(Picture 8)

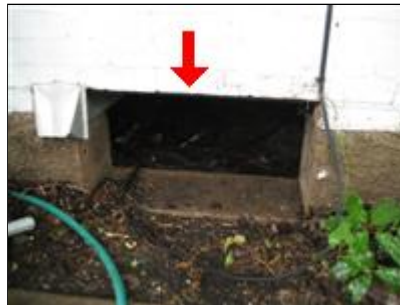
A. Picture 9

(4) Crawlspace entry at rear of structure needs to be closed off or have a door entry installed to keep out rodents and pest.(Picture 9)

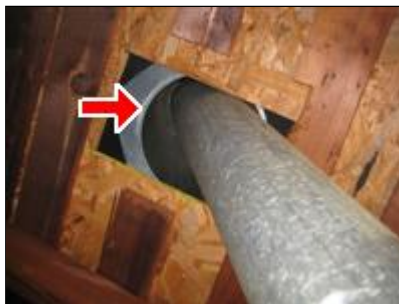
D. Picture 1

(1) Openings around vent stacks and piping inside attic space can allow water intrusion if not corrected. Recommend applying sealant as necessary around vent protrusions around the ceiling inside attic space.(Picture 1)

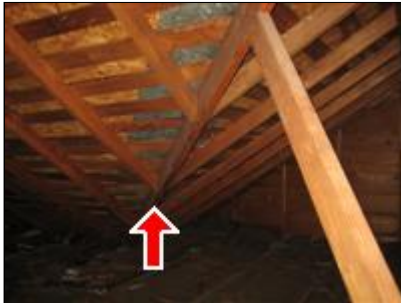
(3) Additional rafter supports are needed in ceiling structure inside attic space. Existing rafter supports are weak and limited in areas. By adding purlins and supports can increase the stability in the roof structure if applied. Recommend further evaluation(s) and/or service be performed by a qualified expert.(Picture 3)(Picture 4)(Picture 5)

D. Picture 3 VALLEY RAFTER SUPPORT NEEDED

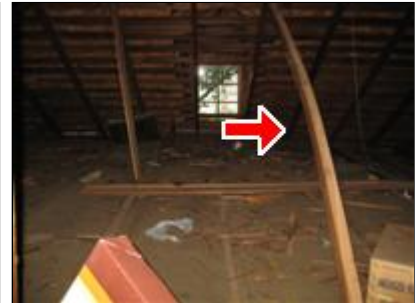
D. Picture 5 WEAK / UNSTABLE SUPPORTS

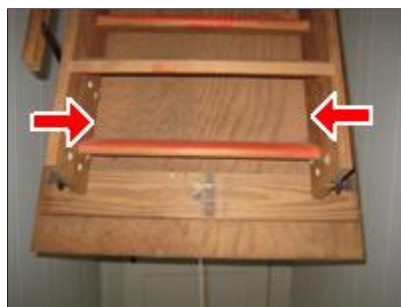
D. Picture 6

(4) **FYI (For your information):** Insulation missing at back of attic stair access. Energy loss can occur from this location that can affect heating and cooling efficiency levels within the structure if not corrected. Recommend adding insulation as necessary for efficiency reasons.(Picture 6)

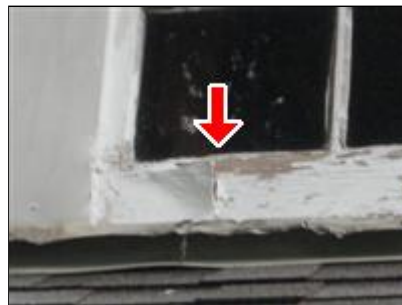
E. Picture 5

(3) Paint surfaces deteriorated on front dormers, with wood-rot in horizontal fascia boards under metal-clad siding at front, sides, and back of structure. Further deterioration can occur if not corrected. Properly installed rain gutter system can also protect the structure from exposure to water penetrations if applied.(Picture 5)

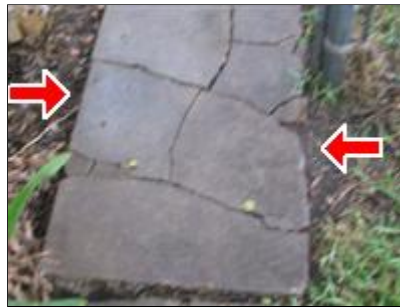
K. Picture 1

Crack(s) in sidewalk at front and back of structure is considered a trip hazard until corrected. Recommend repair or replace as necessary.(Picture 1)

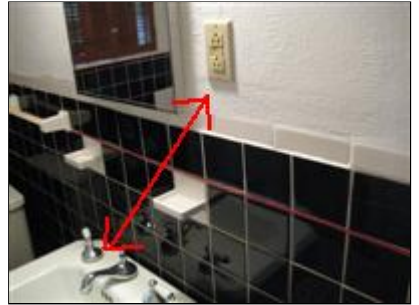
(2) Exterior electrical outlets were operable at the time of the inspection but had no Ground Fault Circuit Interrupter (GFCI) protection. Although, GFCI protection of exterior circuits may not have been required at the time in which this home was built, as general knowledge of safe building practices has improved with the passage of time, building standards have changed to reflect current understanding. The Inspector recommends updating the existing exterior electrical circuits to include GFCI protection.(Picture 1)(Picture 2)(Picture 3)(Picture 4)(Picture 5)

B. Picture 3 GFCI NON-FUNCTIONING

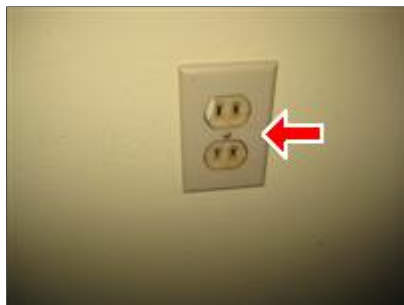
B. Picture 9

🏠 (4) Outlets at various locations inside structure are "two-wire" and are not grounded. Two wire outlets are acceptable due to age of structure, but some appliances cannot be plugged into outlets or will not work without a ground. Recommend repair or replace as necessary.(Picture 9)(Picture 10)

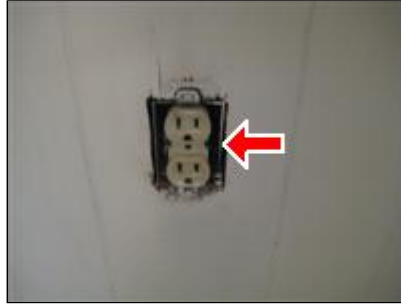
B. Picture 11

(5) Cover plate missing over electrical outlets in dinning room location. Shock or personal injury can occur if not corrected.(Picture 11)

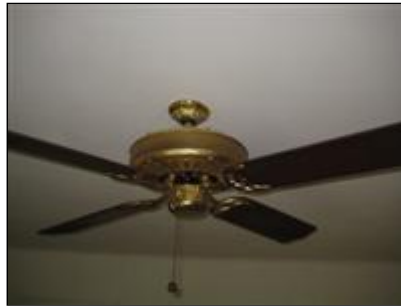
B. Picture 12

(6) Ceiling fan did not function when tested at various locations inside structure. Ceiling fan replacement may be necessary.(Picture 12)

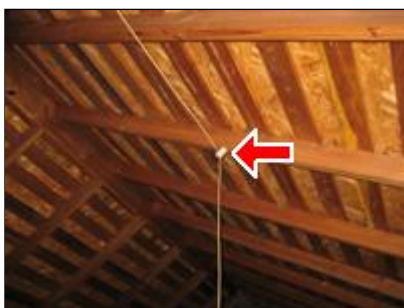
B. Picture 15

(9) The attic is poorly insulated and "Knob and Tube" wiring is present. As a safety rule Knob and Tube wiring should never have insulation covering this wire or over heating can occur. If new insulation is added, an electrical contractor should first replace knob and tubing wires with updated wiring.(Picture 15)(Picture 16)

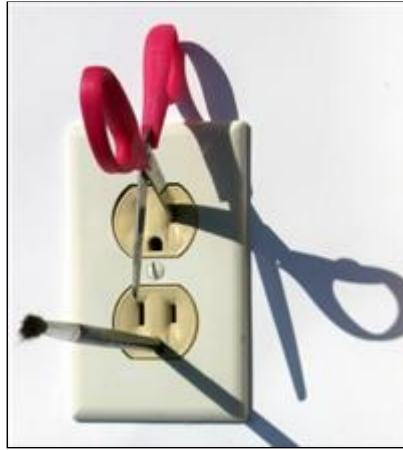
**NOTE:** AFCI breakers are now required to be installed in all living and bedroom circuits. These safety devices are intended to detect the kinds of electrical arcs that can cause fire and/or personal injury. An AFCI breaker is designed to trip when it detects a dangerous arc, either in the house wiring, when hot's and neutrals are accidentally crossed, defects in an extension cord, and/or appliance.

B. Picture 17 AFCI CAN  
PROTECT FROM THIS!

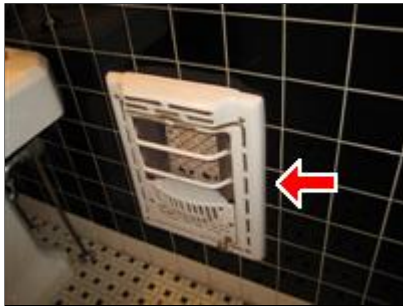
(1) Wall heaters did not function when tested at time of inspection, due to no gas utilities. Gas fired wall heaters are dis-allowed by today's standards and are considered a fire hazard. Recommend capping off and/or removing these units as necessary for safety.(Picture 1)(Picture 2)(Picture 3)(Picture 4)

A. Picture 1 GAS WALL HEATER

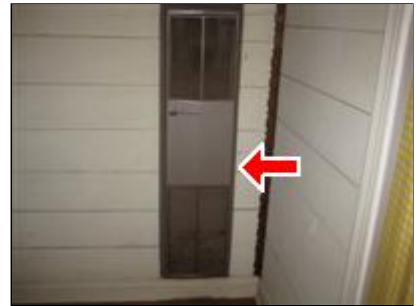
A. Picture 3 NO GAS TO WALL HEATERS

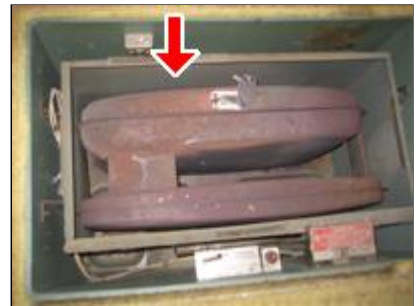
A. Picture 7 OLD & RUSTED OUT HEAT EXCHANGERS

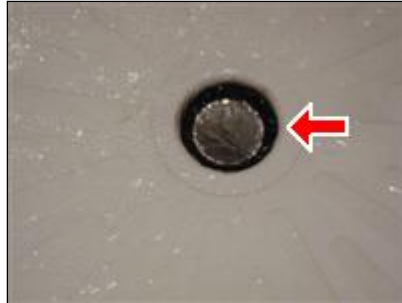
B. Picture 1

(1) Screened drain cover missing on shower pan at hallway bathroom inside structure.(Picture 1)

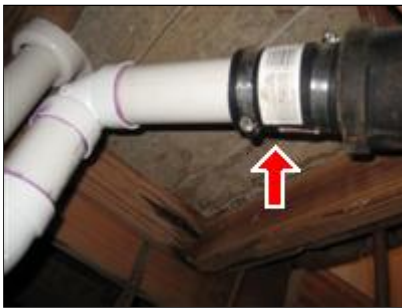
B. Picture 2

(2) Rubber union connectors are considered a temporary fix that can eventually leak over time at areas under structure. A more permanent connection device should be applied in areas where rubber unions are present.(Picture 2)(Picture 3)(Picture 4)(Picture 5)(Picture 6)

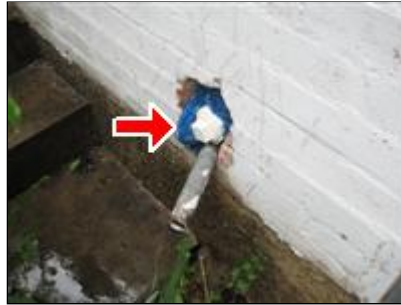
B. Picture 7

(3) Plumbing clean-out is loose in wall and does not appear to be properly installed at right side (Facing front) of structure. Galvanized steel piping protruding out around clean-out can also be a hazard if not removed. I am unable to determine exact purpose for this application and should be further evaluated and corrected as necessary by a qualified plumbing expert.(Picture 7)

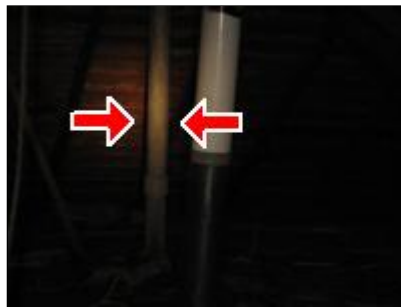
B. Picture 8

(4) Observed asbestos B-vent piping attached to the water heater inside attic space. Asbestos material is not a hazard until disturbed and/or moved. But, there is still a risk to consider having this kind of material around and should be corrected as necessary for safety.(Picture 8)

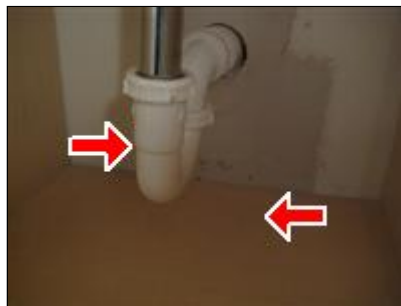
B. Picture 9

(5) Water leakage from drain piping under sink at 1/2 bath location. Further water damage can occur if not corrected.(Picture 9)

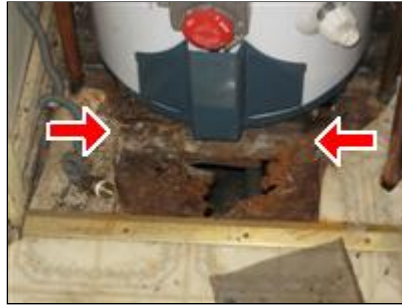
C. Picture 1

(1) Wood supporting water heater is badly deteriorated to the point that the unit could fall through the floor. Therefore, causing significant damage and possible gas leakage if not corrected.(Picture 1)

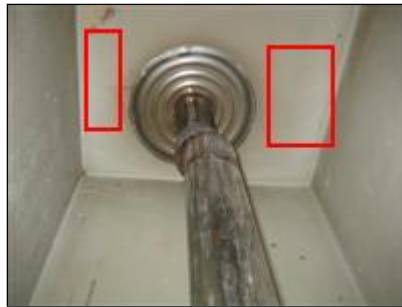
C. Picture 2

(2) Additional draft ventilation is needed inside closet space where gas water heater is located to vent out harmful gas fumes that can collect inside the structure. Dilution air vents and ducting are needed around the burner-plate at base of water heater, in addition to help draw out harmful carbon monoxide gas build-up and should be present as necessary for safety.(Picture 2)

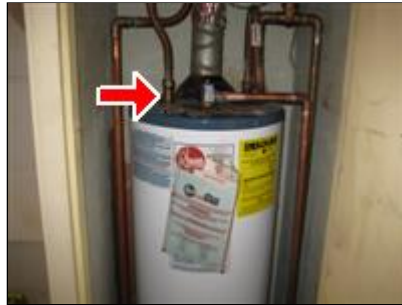
C. Picture 3

(3) Corrosion around fitting connections at top of water heater can eventually fail and develop leaks if not corrected. Water heater may need replacement.(Picture 3)

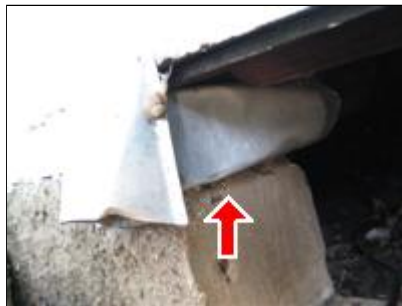
J. Picture 1

Dryer vent damaged and is poorly or improperly installed around crawlspace access location at rear of structure.(Picture 1)(Picture 2)
