Inspection Report

Property Address:
500 Sea Breeze Dr
Dallas TX 75104

PROPERTY INSPECTION REPORT

By: Kevan Brent Giles TREC # 7297 / Spec-Pro Inspection Services, LLC 6/18/2010

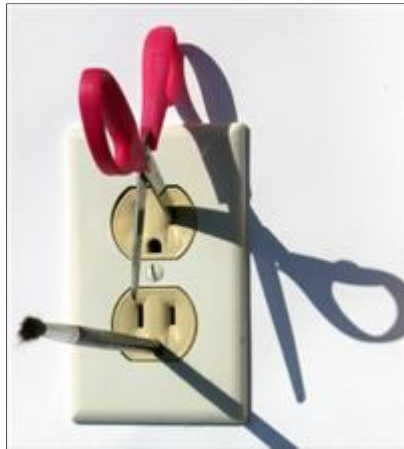
B. Picture 21 Why AFCI? Safety!

consider the benefits of installing them as necessary for safety when children are present.(Picture 21)(Picture 22)

NOTE: AFCI breakers are now required to be installed in all living and bedroom circuits. These safety devices are intended to detect the kinds of electrical arcs that can cause fire and/or personal injury. An AFCI breaker is designed to trip when it detects a dangerous arc, either in the house wiring, when hot's and neutrals are accidentally crossed, defects in an extension cord, and/or appliance.

(9) The electrical system does not have AFCI (Arc-fault circuit interrupters) protection at required locations in bedrooms and living areas as necessary for safety. **This standard was *not* enforced and may *not* have been required when the home was constructed.** AFCI Protected outlets were effectively introduced January 1st, 2002, and was mandated by the NEC (National Electric Code) to protect 15 and 20 amp branch circuits servicing bedrooms in new construction. This is not a new home, so simply consider the benefits of installing them as necessary for safety when children are present.(Picture 21)(Picture 22)
