# Inspection Report

**Property Address:**  
5006 Monticello Rd  
Dallas TX 75206

**Spec-Pro Inspection Services, LLC**

**By:** Kevan Brent Giles TREC # 7297 / Spec-Pro Inspection Services, LLC 6/9/2010  
\_\_\_\_\_  
(Name and License Number of Inspector) (Date)  
\_\_\_\_\_  
(Name, License Number and Signature of Sponsoring Inspector, if required)

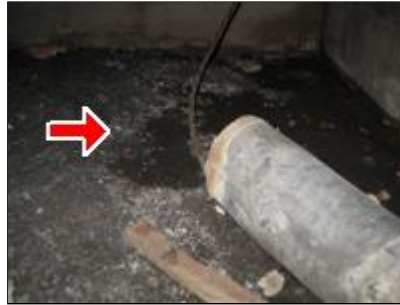
A. Picture 6

(3) White efflorescence (powder substance) on floor-joists and on inside foundation walls indicates moisture is, and/or was, in contact at various locations under structure. A moisture condition may still be present and may require additional ventilation. Efflorescence is found on many homes without water intrusion. But, should alert you to the possibilities of future steps that may be needed to correct this condition.(Picture 5)(Picture 6)(Picture 7)(Picture 8)

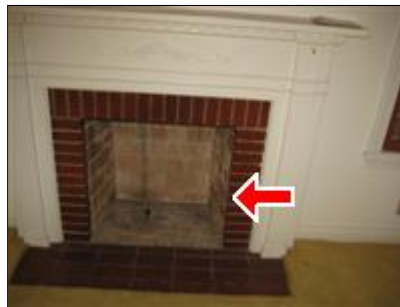
J. Picture 3

(2) I do not inspect the shape of fireplace or the design to determine if your fireplace has a proper air draw.(Picture 3)

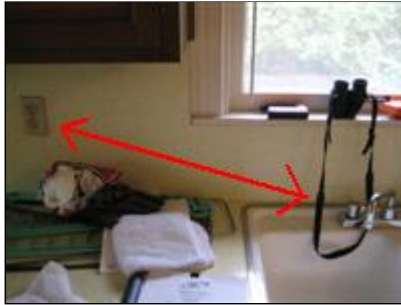
B. Picture 2 NO GFCI WITHIN 3' OF WATER SOURCE

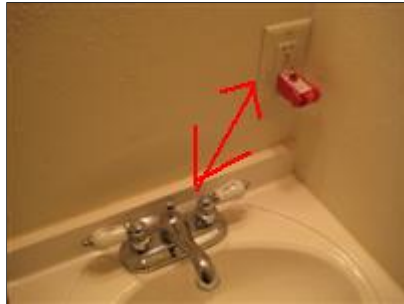
B. Picture 4 NO GFCI IN BATHROOMS

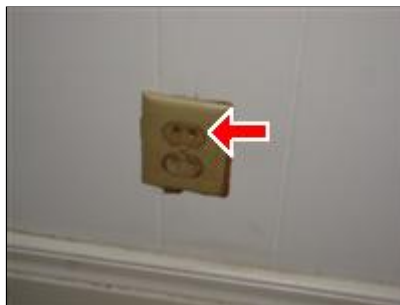
B. Picture 10

🏠 (4) Outlets at various locations inside structure are "two-wire" and are not grounded. Two wire outlets are acceptable due to age of structure, but some appliances cannot be plugged into outlets or will not work without a ground. Recommend repair or replace as necessary.(Picture 9)(Picture 10)

(4) Outlets at various locations inside structure are "two-wire" and are not grounded. Two wire outlets are acceptable due to age of structure, but some appliances cannot be plugged into outlets or will not work without a ground. Recommend repair or replace as necessary.(Picture 9)(Picture 10)

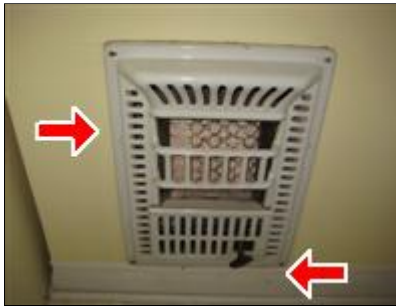
A. Picture 2 DISALLOWED BY STANDARDS

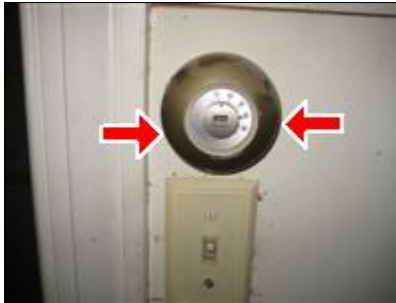
A. Picture 4 NON-FUNCTIONING

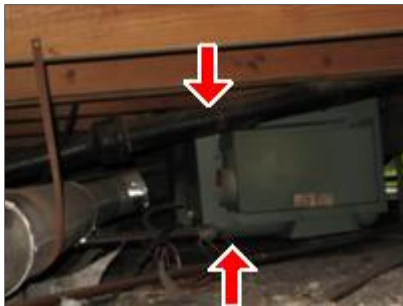
(2) Old heating equipment should be updated, serviced, and/or removed as necessary for normal function. Gas fired wall heaters and floor furnaces are no longer allowed by today's standards and should be thoroughly evaluated or serviced as necessary before further usage by a heating and cooling expert.(Picture 5)(Picture 6)(Picture 7)(Picture 8)

A. Picture 5 FLOOR FURNACE

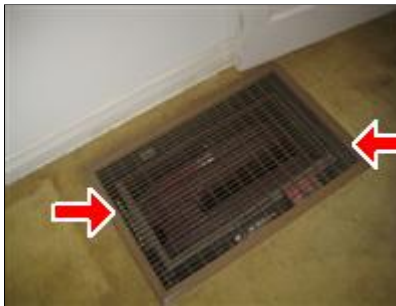
A. Picture 6 FLOOR REGISTER
